HIGH SPEED SBQ CASTING AT CHAPARRAL STEEL

KERRY LEGEARD* and MIKE DALBY

TXI Chaparral Steel, Midlothian, TX 76065, USA

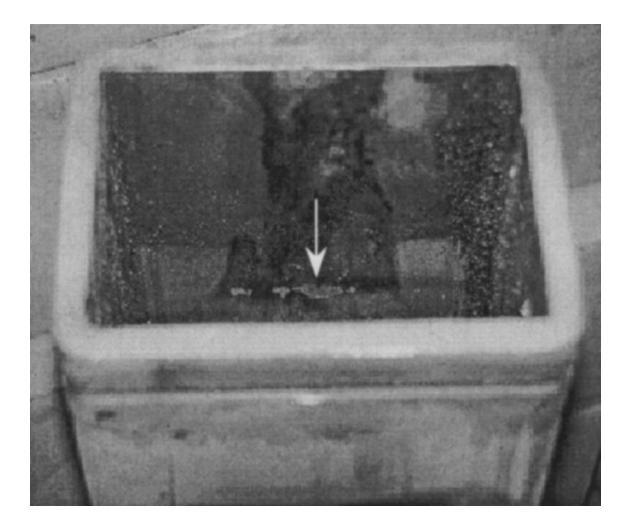
Mold life has proven to be one of our greatest challenges, and earlier this year we began to experience a high frequency of chrome chipping and copper cracking at the meniscus level. Figure 5 is a photograph of one of our molds showing

Fig. 5. $5 \times 6\frac{3}{4}$ " mold tube exhibiting chrome chipping at the meniscus location (arrow).

some typical chrome chipping. During this period, this type of chipping was often associated with heavy longitudinal cracks in the Cu–Cr–Zr substrate of the mold.

The immediate problem was alleviated somewhat by removing the recycled EAF dust, relocating the meniscus to a lower level, and boosting the mold cooling water flow rate by 12 GPM, the maximum flow rate available to us in the short term. We have also recently installed booster pumps to our existing mold water cooling system during our summer shutdown, which should help to further reduce the mold hot face temperatures and these types of failures.

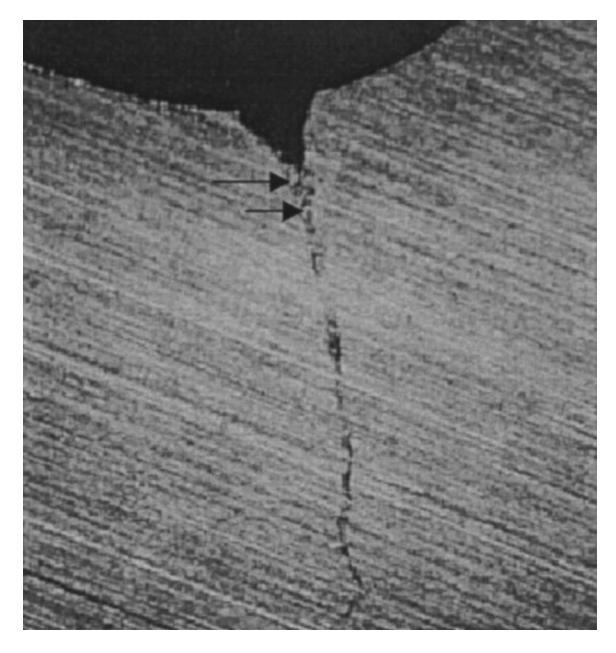
On one of the molds that we were able to destructively test, metallography revealed that the cracks under the chipped chrome had metallic deposits consisting mainly of zinc and lead (Fig. 6).

In addition, hardness measurements taken transversely on the surface of the cracked face showed significant softening compared to the adjacent non-cracked face (Table 1).

Fig. 6. Longitudinal cracks under chrome chipping with zinc and lead deposits.

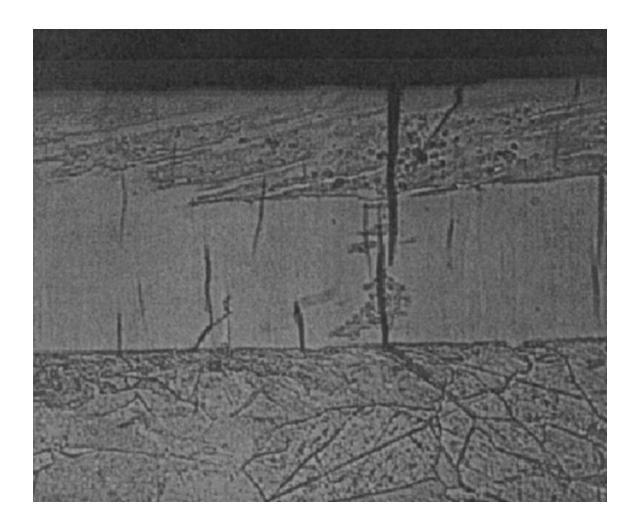
Further study of the literature [2] suggested that the mechanism for the chrome chipping was zinc penetration through microcracks in the chrome (Fig. 7). The zinc then reacts with the copper substrate to form intermetallic brass resulting in a volume increase which causes the plated chrome to "lift off".

Once the chrome chips, the Cu–Cr–Zr substrate is directly exposed to the solidifying steel shell and eventually cracks due to thermal cycling and high temperature fatigue. At Chaparral, this mechanism was being aggravated by our practice of recycling zinc rich EAF dust in the furnace.

Fig. 7. Microcracks in mold chrome plating.

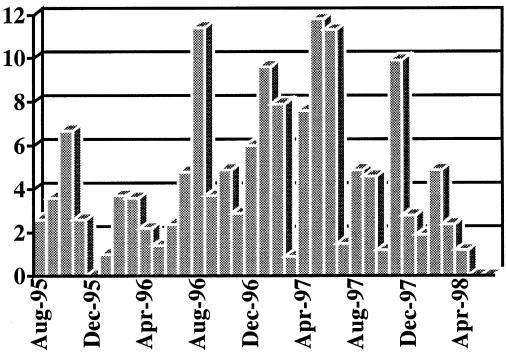
The first issue is transverse corner cracks or TCCs. Figure 8 represents the history of TCCs at Chaparral since the implementation of high speed casting. As you can see we have had 2 successive months without TCCs. The question is how did we get rid of them?

Fig. 8. Transverse corner crack downgrade index.

We believe the reason that TCCs have disappeared is that the lower initial taper at the lower meniscus level reduces the binding between the solidifying shell and the mold, and ultimately reduces the generation of longitudinal stresses on the solidifying shell that can cause transverse corner cracks to form.

If you recall, I mentioned the chipping and cracking problems we were having in the molds in the meniscus area earlier this year. In early February, we decided to move the steel meniscus lower and away from the damaged areas in the mold. This change not only alleviated our mold wear problem, it also resulted in an immediate and drastic reduction in TCCs.

With our new and current lower operating level, we have dropped the meniscus 30 mm to 161 mm from the top of the mold, giving us a taper of just above 2% per meter at the new meniscus level.

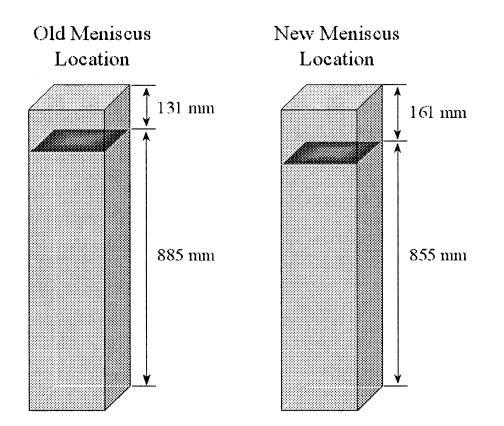
Fig. 10. Previous and current meniscus location.

We believe that hinge cracks have been difficult for us to solve because there are several mechanisms acting against us in eliminating this problem. The first and most obvious mechanism is the loss of effective mold length by running the meniscus at 161 mm. The 30 mm loss of effective mold length means we have a thinner shell at the mold exit, which can be more prone to hinging (Fig. 10).

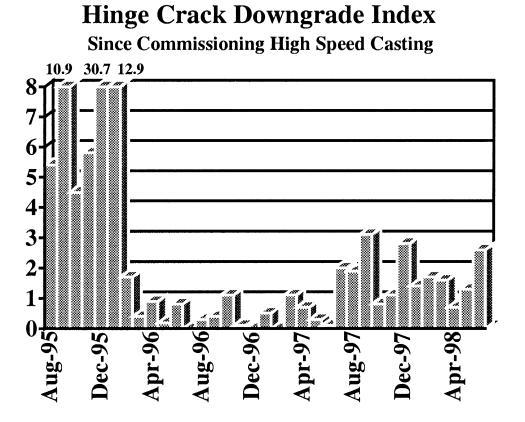
The second largest quality issue we face is Hinge Cracks, also known as off corner internal cracks. In Fig. 9 we have the historical performance of hinge cracks since the implementation of high speed casting. As with TCCs these defects occur primarily on our oil cast products. Hinge cracks still present a significant challenge for us.

Fig. 9. Hinge crack downgrade index.

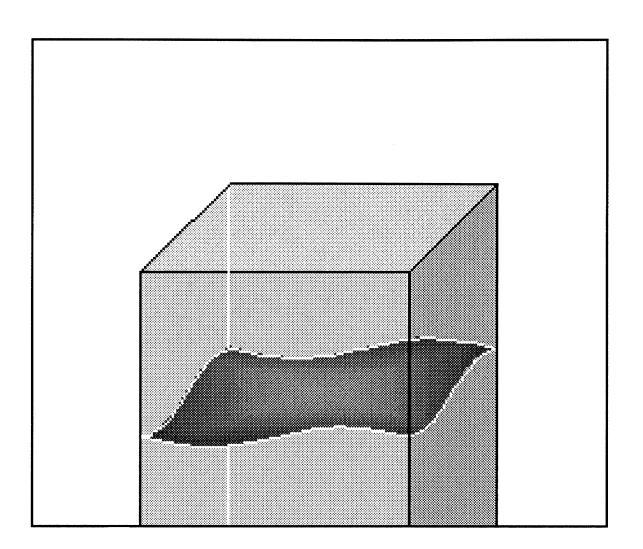
There is strong evidence that the stirring practice on our oil cast silicon killed practice sets up a standing wave in the meniscus area similar to the one shown in Fig. 15.

Fig. 15. Uneven meniscus created on oil cast product.

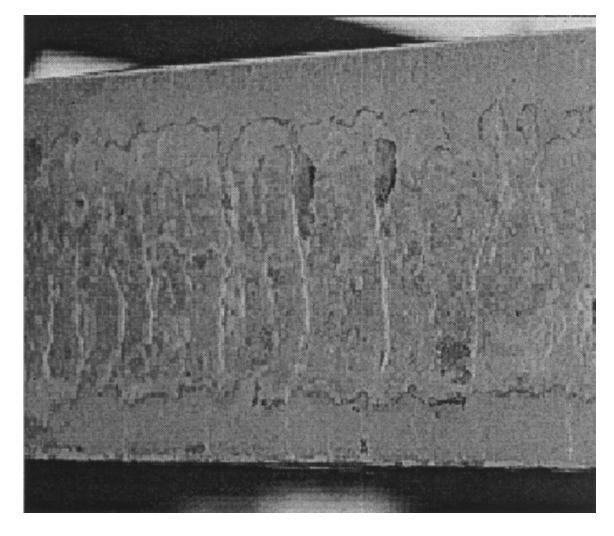
Examination of an oil cast billet (Fig. 16) lends support for this mechanism, although this oscillation mark pattern is more severe than on our typical oil cast, it is not uncommon, and the characteristic sine wave pattern is usually present to some degree. This unevenness at the meniscus, among other things, promotes uneven shell growth, which can lead to hinge crack formation.

Fig. 16. Oscillation marks on oil cast billet.

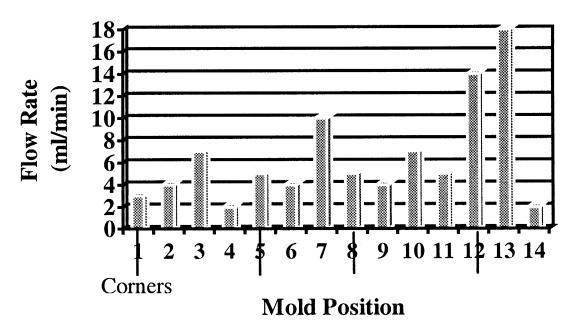
The oil flow has been measured in-situ on several occasions, with the mold divided up into 14 discrete segments. The graph in Fig. 19 shows a typical distribution pattern for a mold and jacket assembly after several heats. There is very little difference in this pattern when we do the same test on a new mold and oil distribution plate, or on a mold and plate with many heats on it.

Consequently, with this type of oil distribution, we are concerned that a quiet meniscus stirring practice, while likely beneficial from a hinge crack reduction standpoint, may magnify the discrepancy in oil delivery already present and result in an increased frequency of stickers and bleeds.

Fig. 19. Typical oil distribution around mold perimeter.

So far, in our efforts to improve our oil delivery distribution, we have modified the shims on the oil distribution plate so they stop $\frac{1}{4}$ " short of the hot face. Distribution measurements taken with this modification in place showed little improvement to the above profile; however we discovered that we were operating under extremely low flow conditions during these trials.

Further work has been proposed and is under way to increase the oil reservoir volume and reduce the horizontal distance the oil has to travel from the reservoir to the hot face.

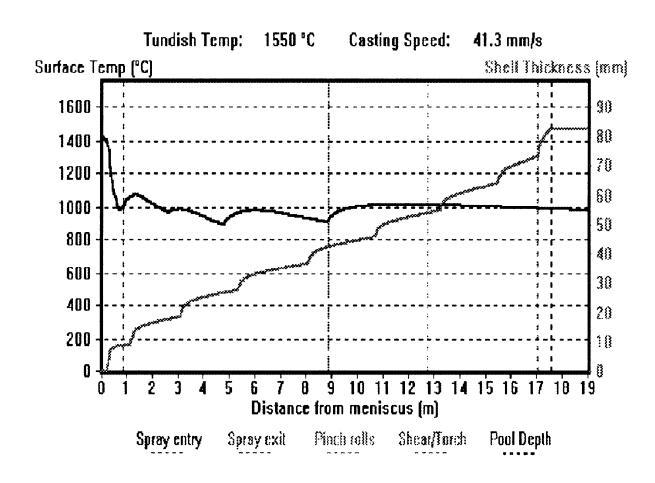
Fig. 20. Predicted surface temperature and shell thickness profiles on grade 1045 for new $6\frac{1}{2}^{"}$ square SBQ billet using our current spray plan.

One envelope we know we will be pushing is the metallurgical length of the new billet, which, at $17\frac{1}{2}$ m is past the torches with our current spray profile (Fig. 20). This means we will require a more aggressive cooling profile, which will present its own set of challenges.
