Assessment of Surface Water Quality in Kakanda: Detection of Pollution from Mining Activities

How to cite this paper: Tshamala, A.K., Musala, M.K., Kalenga, G.K. and wa Mumapanda, H.D. (2021) Assessment of Surface Water Quality in Kakanda: Detection of Pollution from Mining Activities. *Journal of Environmental Protection*, 12, 561-570. <https://doi.org/10.4236/jep.2021.129035>

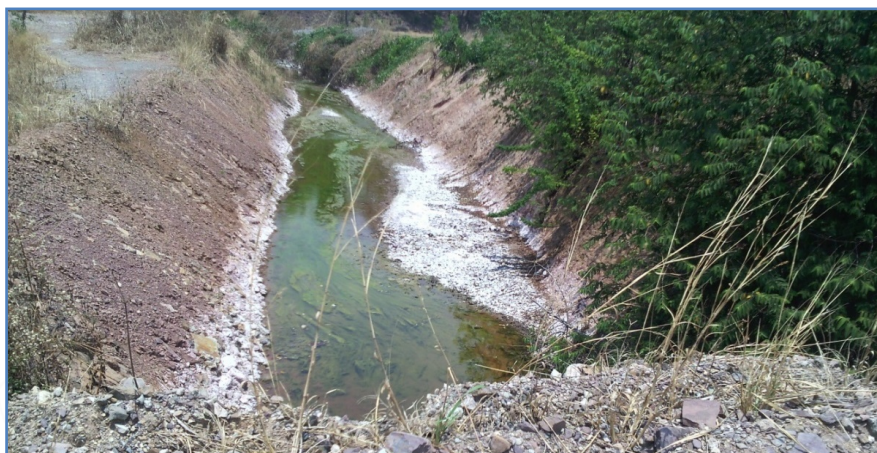
Figure 2. View of a liquid effluent drain from the Luita plant.

The field observations (see photo of **Figure 2**) show that there is a pinkish deposit that forms on the banks of the drain drains Luita factory. The pinkish coloring refers to the saturation of cobalt waters because the cobalt ions have the pink color in solution.

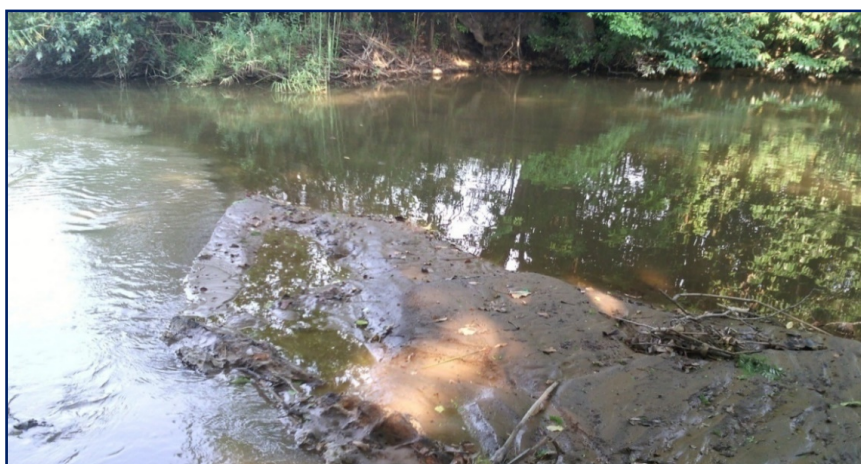
**Figure 3.** View of build-up of Sediments at the Kakanda river water discharge point in the Dikuluwe river.

Field observations also show sediment accumulation at the Kakanda River water discharge point in the Dikuluwe River (photo in **Figure 3**). The Kakanda River is the outlet for various waters generated by Kakanda's mining activities. This highlights that this pollution is of mining activities origin.
