Rehabilitation and field testing of an FRP bridge deck on a truss bridge

Abstract

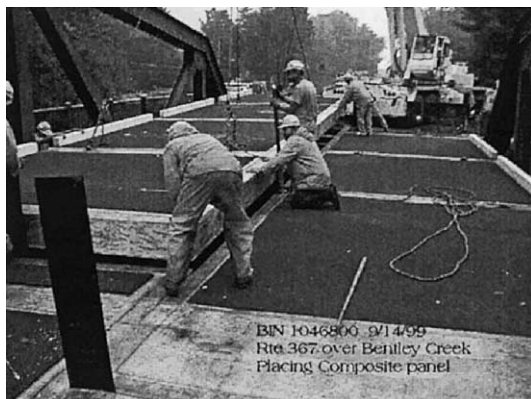
Fig. 2. Composite deck panels during installation.

The old deck was replaced with a lighter GFRP deck panels, made by Hardcore Composites of Delaware (Fig. 2). The deck is a cell core structure made of E-glass stitched fiber fabric wrapped around 150 mm × 300 mm × 350 mm isocyanate foam blocks used as stay-in-place-forms. The deck was designed for AASHTO MS23 live-load [4] using finite element analysis. Orthotropic in-plane properties were used in the analysis. Stresses in the composite materials were limited to 20% of their ultimate strength; and deflection was limited to span/800.

The deck panels were designed to span between the floor-beams. The connection details were designed to prevent composite action between the deck and the superstructure. The panels were connected to each other using epoxy. The epoxy joints consist of a longitudinal joint that runs the entire length of the bridge and four transverse joints that each span one lane. A 10-mm thick Transpo T-48 epoxy thin polymer overlay was used as the wearing surface of both the deck and sidewalk. More details on deck fabrication, design details, and construction procedures can be found in Alampalli and Kunin [1].

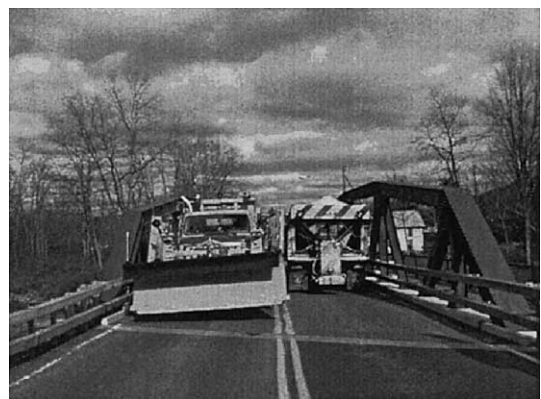
Fig. 3. Load testing.

The FRP deck and a steel floor-beam were instrumented with strain gages at selected locations to meet the objectives of the testing. A total of 18 strain gages were used, 6 bonded to a steel floor-beam and 12 bonded to the bottom face of the FRP deck. Two NYSDOT dump trucks were used to load the bridge (see Fig. 3). Each fully loaded truck closely resembles a M-18 AASHTO live-loading [1,4]. Both static and semi-static tests were conducted. In the semi-static case, each truck was driven across the bridge—only one truck was on the bridge at a time—in the northbound lane at 5 km/h.

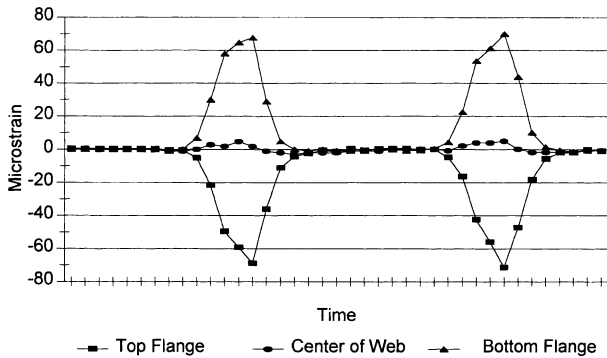
Fig. 4. Data from strain gages on steel floor-beam.

Strain gages were mounted on a steel floor-beam supporting the FRP deck to determine neutral axis of the deck–floor-beam system. The results showed that the

strains in bottom and top flanges are almost the same except for the sign, with negligible strain at the center of the girder (see Fig. 4). This indicates that the neutral axis of the girder is unchanged with the addition of the FRP deck. This validates the design, which assumed no composite action between the deck and the floor-beams.

The maximum longitudinal and transverse stresses during the load tests were 2.9 and 1.6 MPa, respectively. These values relatively small when compared to ultimate strength of the FRP decks (221 MPa). Thus, the deflection criteria, limiting maximum deflection to span/800, controlled the design. Figs. 4 and 5 show the strain distributions, under semi-static live load, in both the

floor-beam and the bottom face of the deck. The data shows that the deck strains directly under wheel loads are a combination of global bending and local bending. The results show that the strains are very high under the wheel loads and rapidly decrease (when compared to floor-beam strains), indicating that local bending effects dominate the deck strains. These local effects may play a major role in the performance of bridge components such as wearing surfaces and should be properly accounted for in future designs.
