Effects of ballistic impact damage on fatigue crack initiation in Ti–6Al–4V simulated engine blades

The ingestion of debris into jet engines creates nicks and dents on the leading edges of blades and vanes. This is commonly known as foreign object damage (FOD). Such damage, which can often result in premature failure, was simulated in the laboratory using diamond cross-section axial fatigue samples that were impacted with 1 mm diameter glass beads at 305 m s⁻¹ at either 0 or 30° angle of incidence. The samples had either a thin leading edge (LE) with a radius of 0.127 mm or a thick LE with a radius of 0.381 mm. Fatigue strength of impacted specimens showed degradation of 10–50% due to LE damage, regardless of the depth of the damage zone. FOD related impact notch depth, loss of material (LOM), shear, folds, embedded shattered glass, and microstructural damage were characterized by SEM. Fatigue strength degradation was found to be higher for the 30° impacts than for the 0° impacts. No clear correlation between notch depth or LE thickness and fatigue strength was found. © 2002 Elsevier Science B.V. All rights reserved.

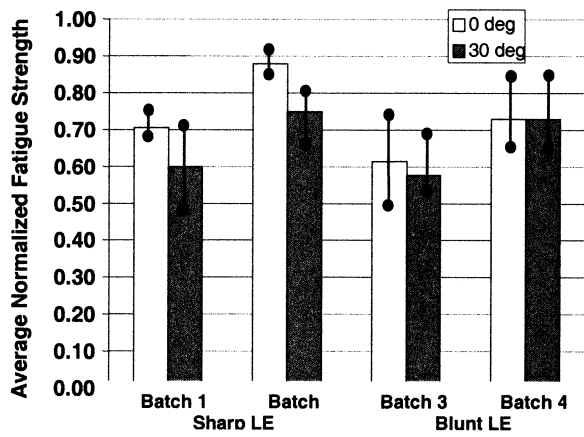
Fig. 6. Average normalized fatigue strength of batches 1 through 4.

All impacted samples exhibited a noticeable decrease in fatigue strength. This is as expected since the impacts produce a notch which results in a stress concentration factor larger than 1. The 0° impacts appear to have less fatigue strength degradation than the 30° impacts (Fig. 6). A surprising observation was the slightly higher fatigue strength of the thin LE samples than that obtained in the thick LE, samples, both subjected to similar FOD impacts. However, data scatter may imply that the thin LE samples were statistically no worse than the thick ones.

Approximately, 80% of the 0° shots fired at the thin LE samples hit the leading edge slightly off center and were deflected. Photographs of representative 0° impacts for both the thin and the thick edges can be found in [11]. The deflected shots created little damage to the leading edge while producing a dent similar to what is observed in the 30° shots. While the material was shifted to one side, the magnitude of the residual compressive and tensile stresses is not necessarily identical to that of the 30° shots, as discussed above. This may be one reason why the 0° impact samples showed slightly higher fatigue strength than the 30° impact samples (Fig. 6), especially for the thin edge samples. In

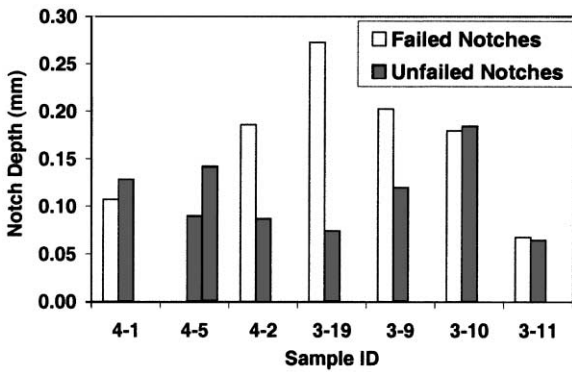
Fig. 9. Depth of failed vs. un-failed notches for 0° impacts in both thin and thick LE. (In sample 4-5, failure occurred outside of the notches).

Fig. 9 plots a comparison of the depth of the failed notch, where crack initiation occurred, and the un-failed notch, for each specimen impacted at 0°. In a majority (65%) of the cases, when failure could be associated with a notch, initiation occurred at the deeper of the two notches. The average damage depth of failed notches is 0.20 mm while for un-failed notches it is 0.12 mm. Whereas the 0° impacts failed at the deeper notch 65% of the time, the 30° impacts failed at the deeper of the two 85% of the time, as shown in Fig.

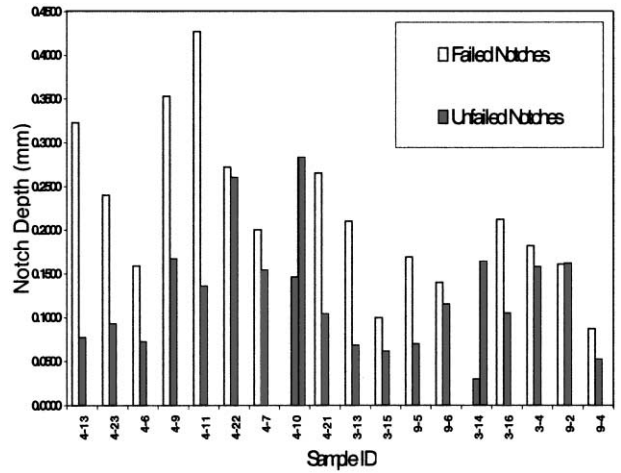
Fig. 10. Depth of failed vs. un-failed notches for 30° impacts for both thin and thick LE.

10. For these tests, Ruschau et al. [8] showed that in spite of the preferred initiation at the deeper of the two notches for a given sample, the depth of the failed notch had no significant effect or systematic trend with respect to the normalized fatigue strength. These results challenge some of the engine inspection and mainte-

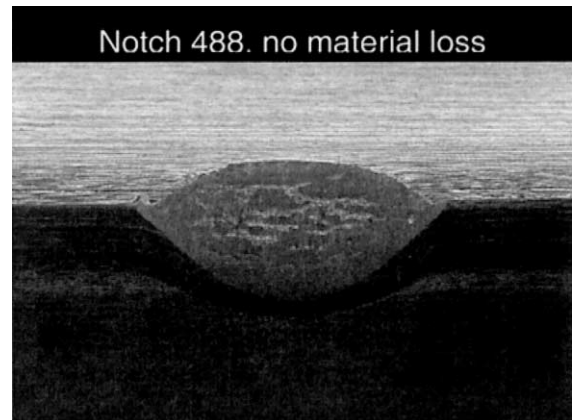
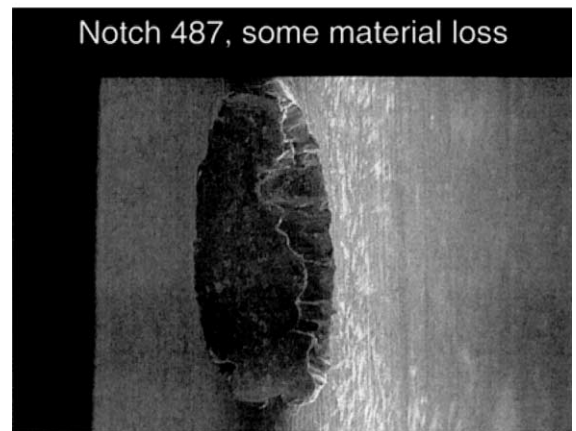
Fig. 11. (a) Loss of Material (thin LE with a 30° impact, sample 4-22). (b) Loss of Material (thin LE with a 30° impact, sample 4-22).

Another feature observed was the LOM from the surface of the notch, which was found on 65% of the failed notches and only 20% of the un-failed notches. Fig. 11a illustrates a shallow notch with no material loss and a smooth surface (see also Fig. 8a). This is a 30° impact, where the bead seems to have only ‘dented’ the leading edge. On the other hand, Fig. 11b shows a rough and jagged notch where there is material loss (see also Fig. 8b). Crack initiation always occurred at the deeper notch exhibiting LOM.

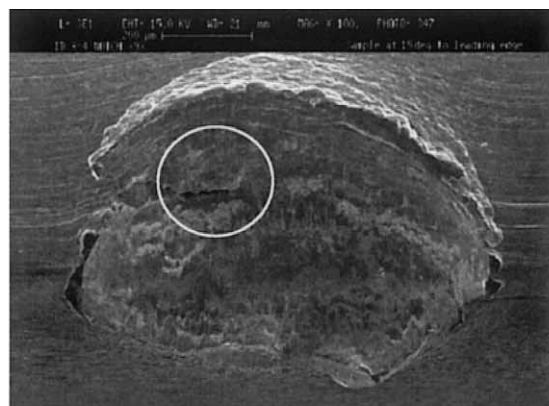
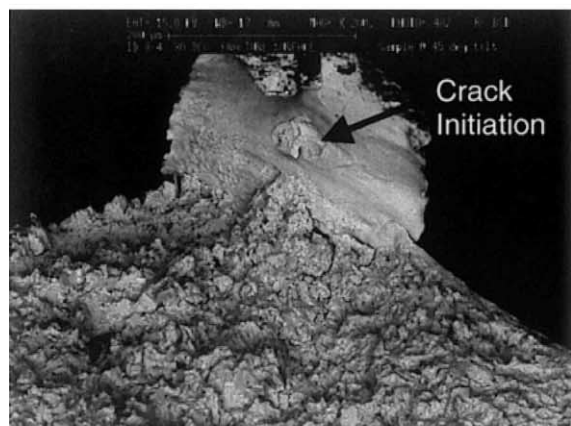
Fig. 16. Before fracture picture of sample 3-4 with a thick Le and a 30° impact, material shear parallel to LE. (b) After fracture photo. (c) After fracture photo behind material shear.

condition of the notch indicates a material shear (or tearing) marked by the circle in Fig. 16a. The post-fracture condition of the notch shows that the fracture initiated somewhere behind the material shear, Fig. 16b and c.
